March 4, 2021

Subject: Discovery of an Unknown Vault with Unknown Fluid Contents NHOU

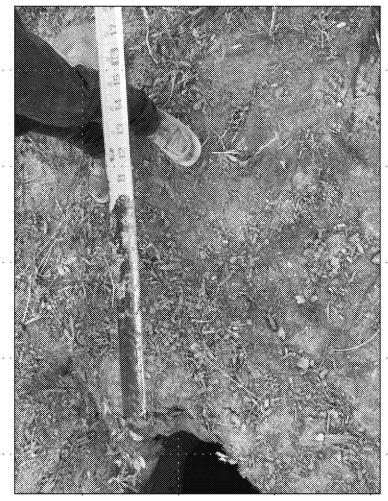
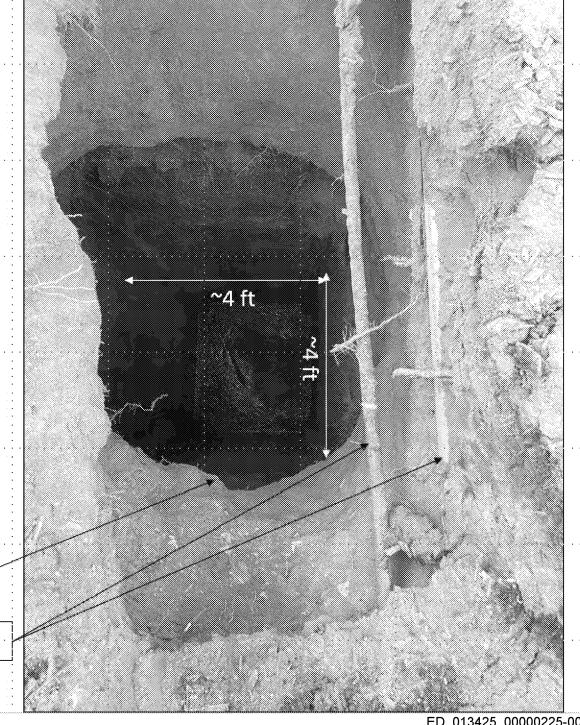
At least one foot of oil (assumed) in vault, 16 ft bgs

Approximately six feet of cover over vault

Exposed water and gas line utilities

We anticipate that the vault contents will need to be characterized and removed; whether the vault itself will also need to be removed in its entirety or can be left in place cannot yet be determined. Characterization of the vault vicinity may also be needed.
